Note on Malformation of Sitka Spruce due to Drift from Hormone Weed Killer.

By R. MCKAY, D.Sc.,
University College, Dublin.

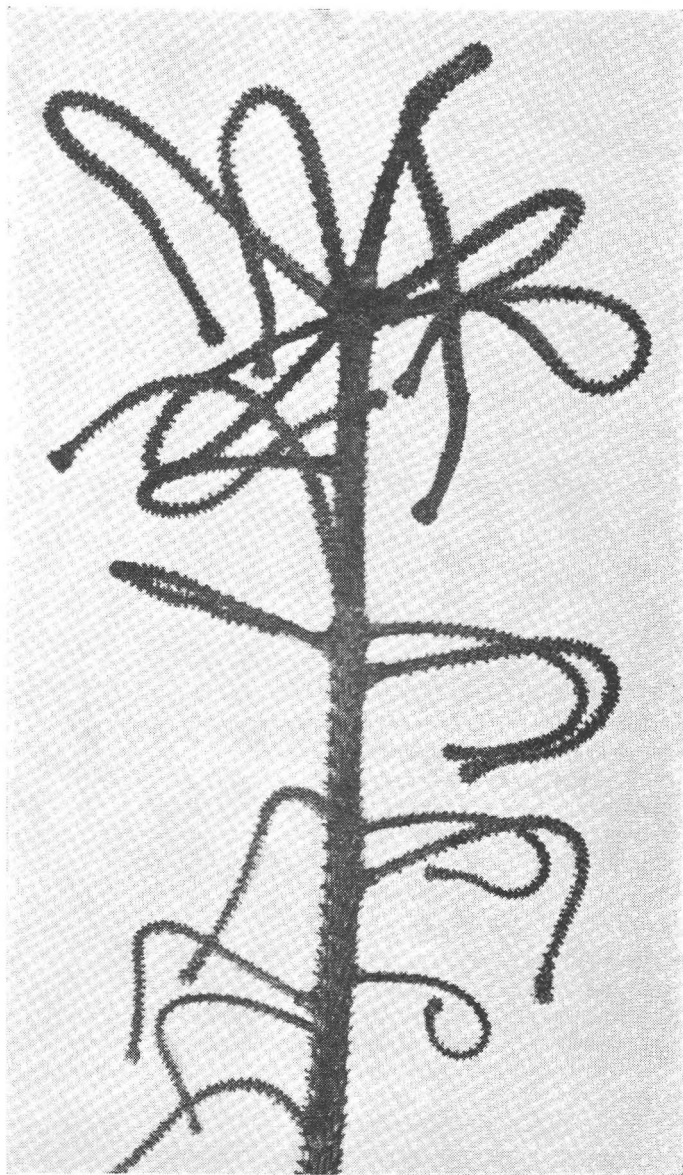
Picture on opposite page is typical of malformed shoots of Sitka spruce (*Picea sitchensis*) submitted for examination in October, 1957. The specimens were forwarded by Mr. P. O'Shea, Horticultural Instructor, Co. Waterford. He reported that about 0.5 per cent. of eight year old trees growing in a shelter belt were affected in this manner. The coiled, twisted shoots were very brittle, but no parasitic organism was present. Investigations revealed that hormone weed-killers had been used in the vicinity of the trees. Furthermore, those most affected occurred in thin parts of the shelter belt, where air currents had evidently carried the drift from the spray deep into the shelter belt.

Malformed shoot of Sitka spruce due to drift from weed killer.
